tech tip

Fouled Focus Ignition Locks

By Richard McCuistian, Contributing Editor

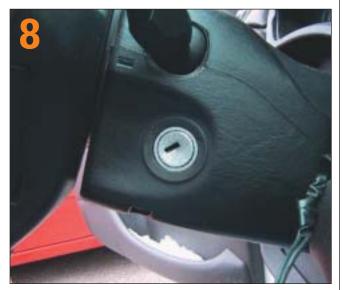
Using the instruction sheet and the tumblers provided with the new lock cylinder, build the new cylinder to match the original key.

Install the new lock cylinder.
